NASA Technical Memorandum 83273

1981 DIRECT STRIKE LIGHTNING DATA

FELIX L. PITTS AND MITCHEL E. THOMAS

This report presents the results obtained during the 1981 direct-strike lightning tests of the NASA Langley Research Center lightning-instrumented F-106B aircraft. The tests were conducted in the vicinity of the National Severe Storms Laboratory, Norman, Oklahoma, and in the vicinity of the NASA Langley Research Center, Hampton, Virginia. The entire strike data obtained for 10 strikes in the 1981 test series are presented in this report.

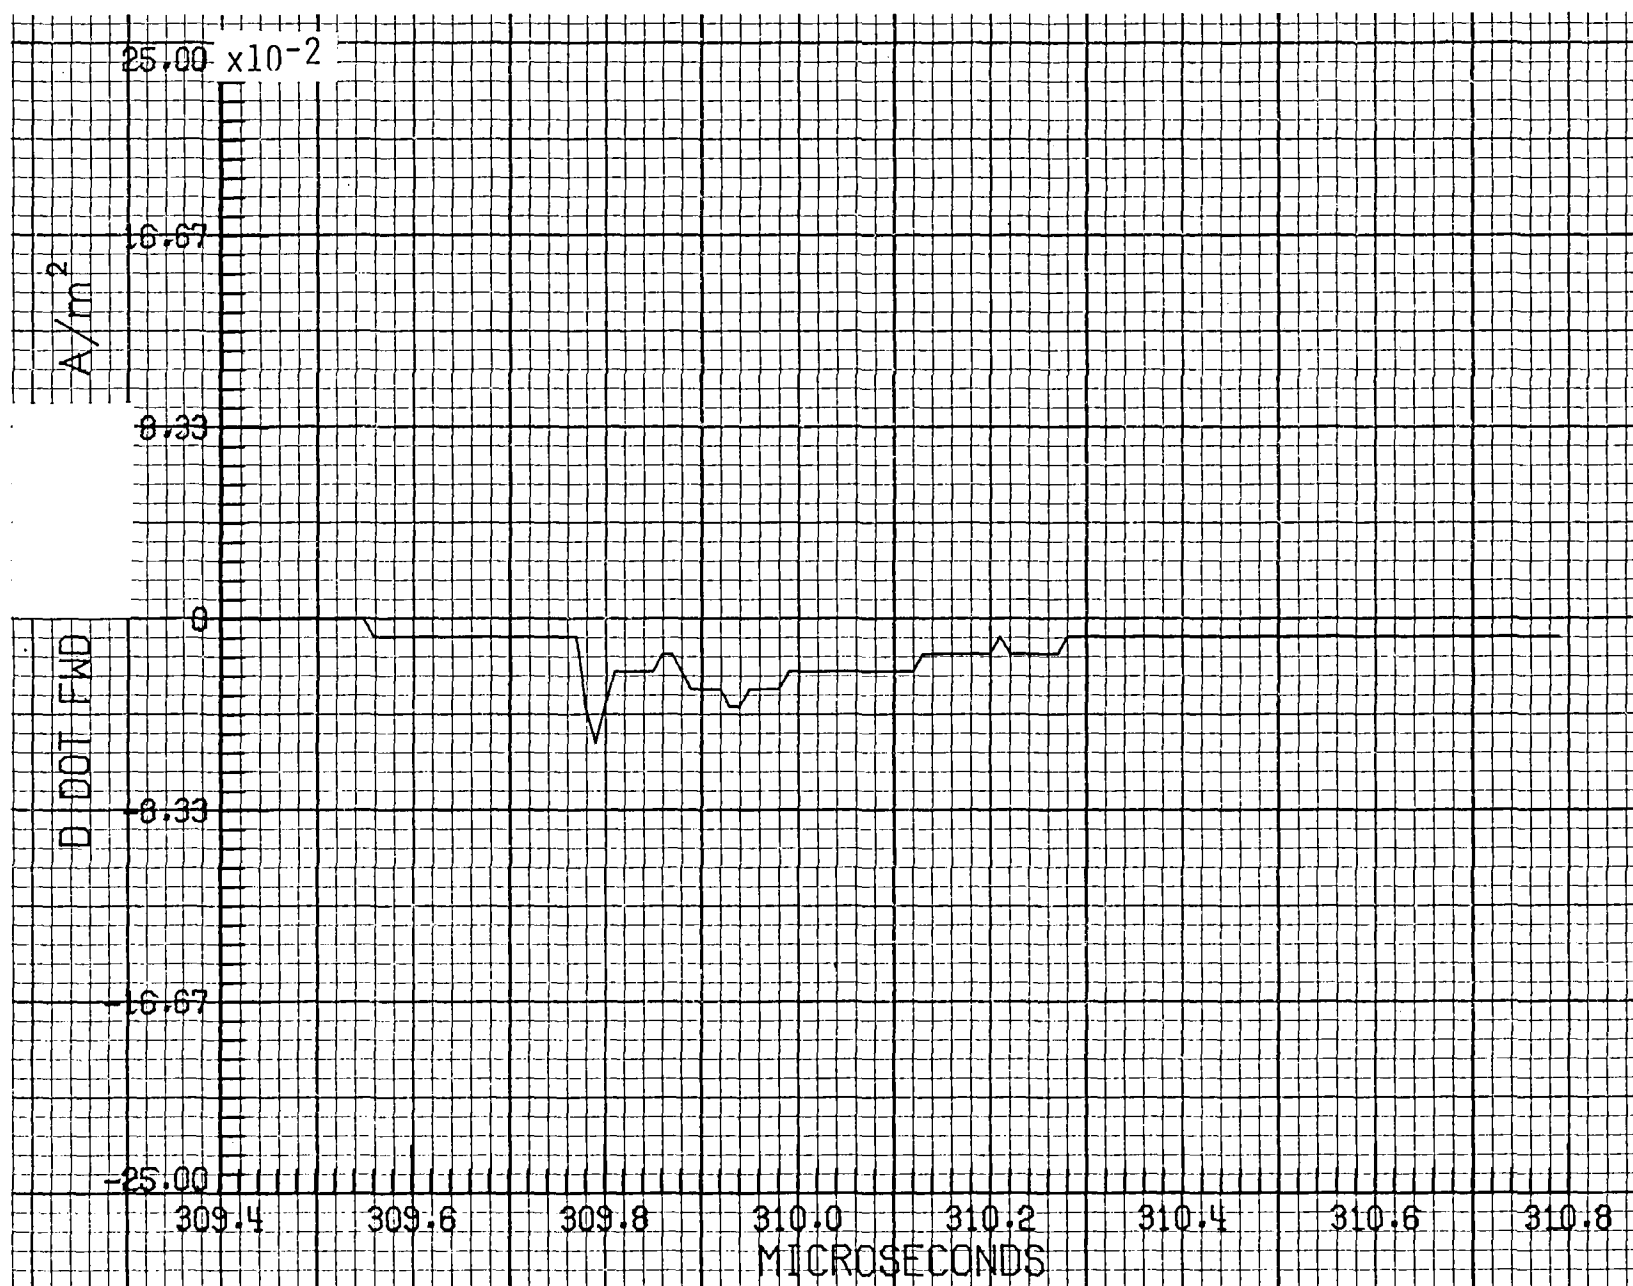
Figure 1. - D-dot sensor - flight 81-026, record 1.

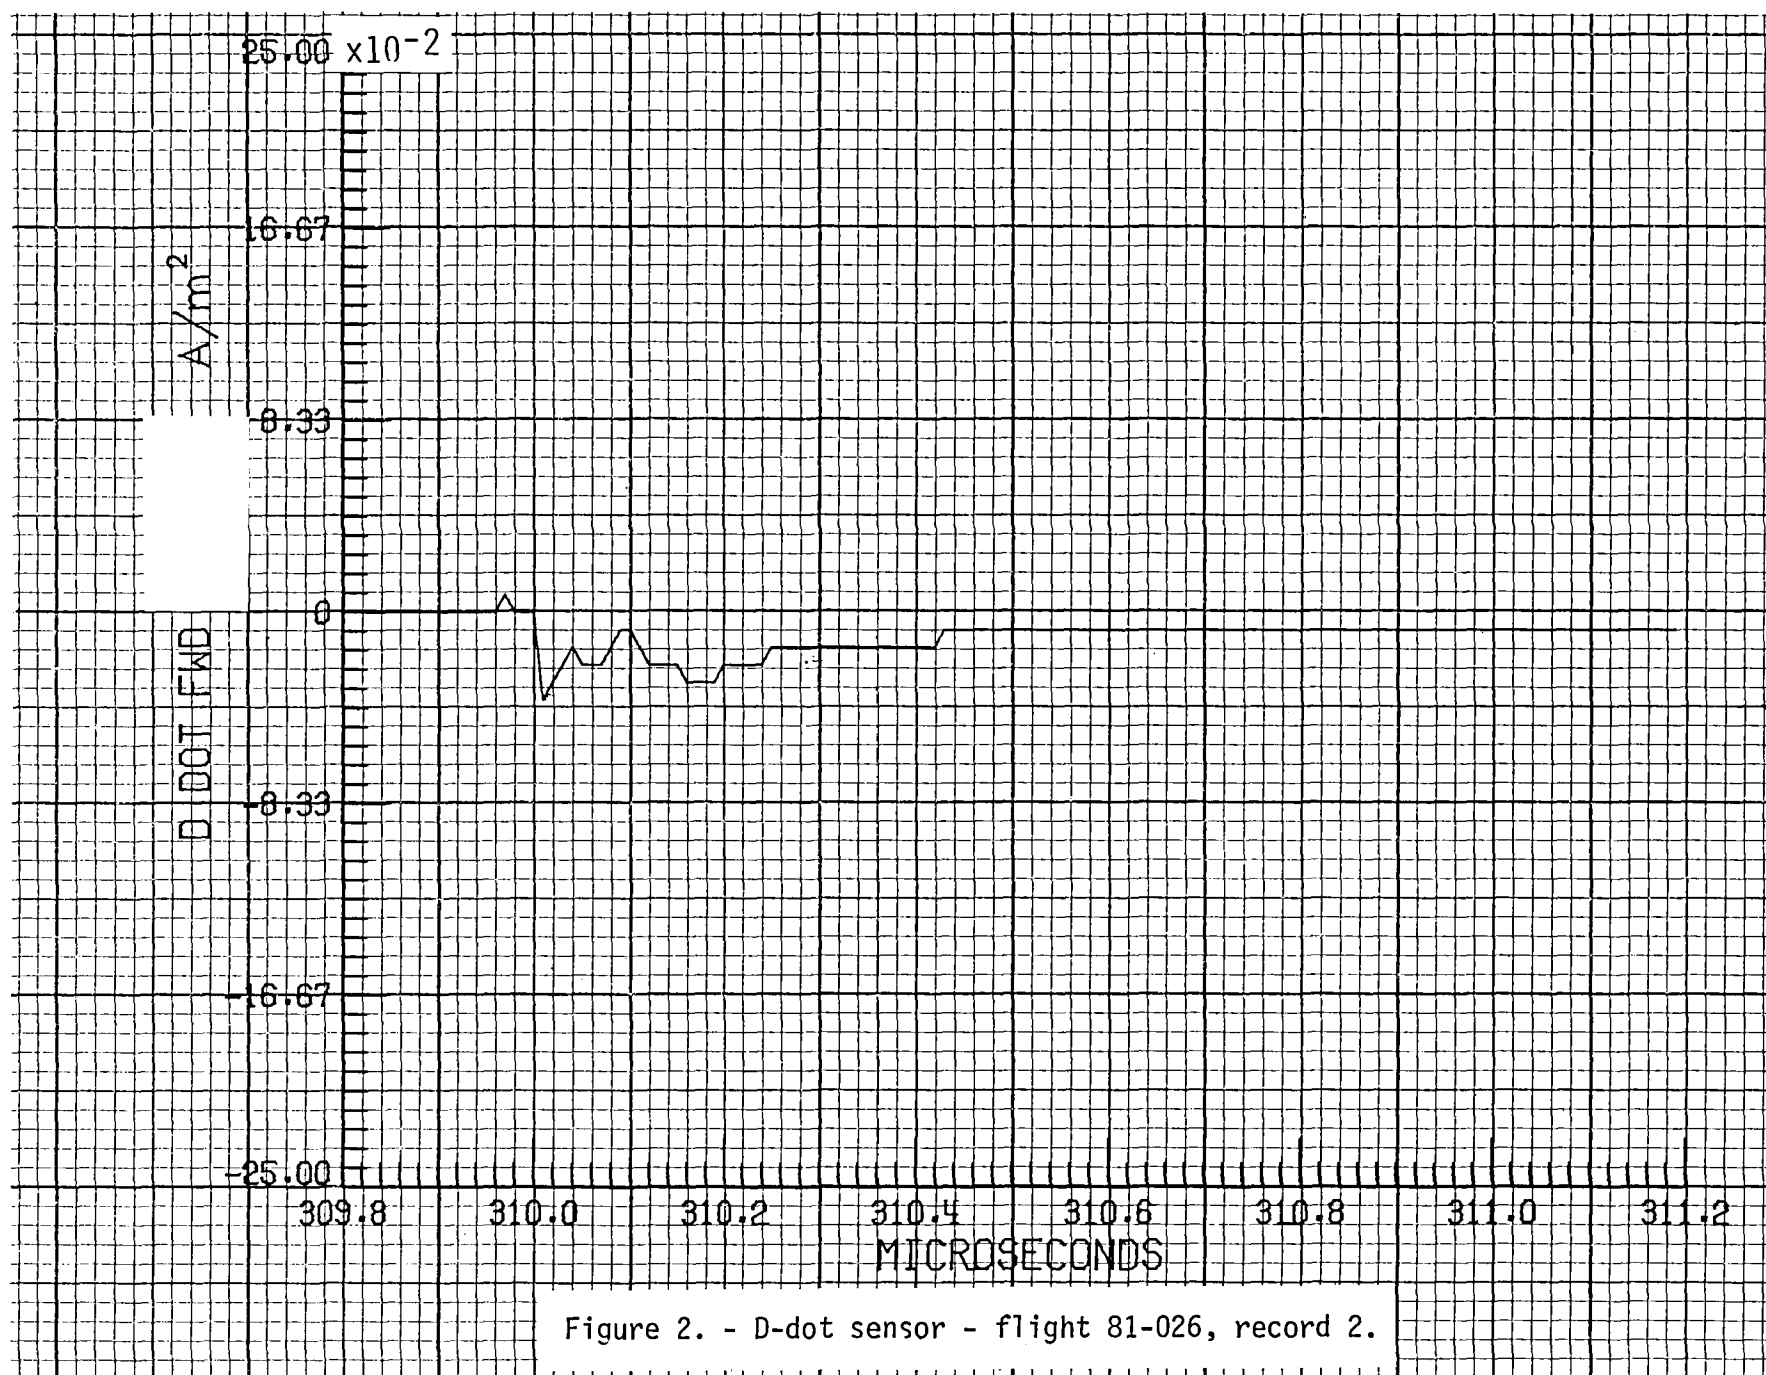
Figure 2. - D-dot sensor - flight 81-026, record 2.

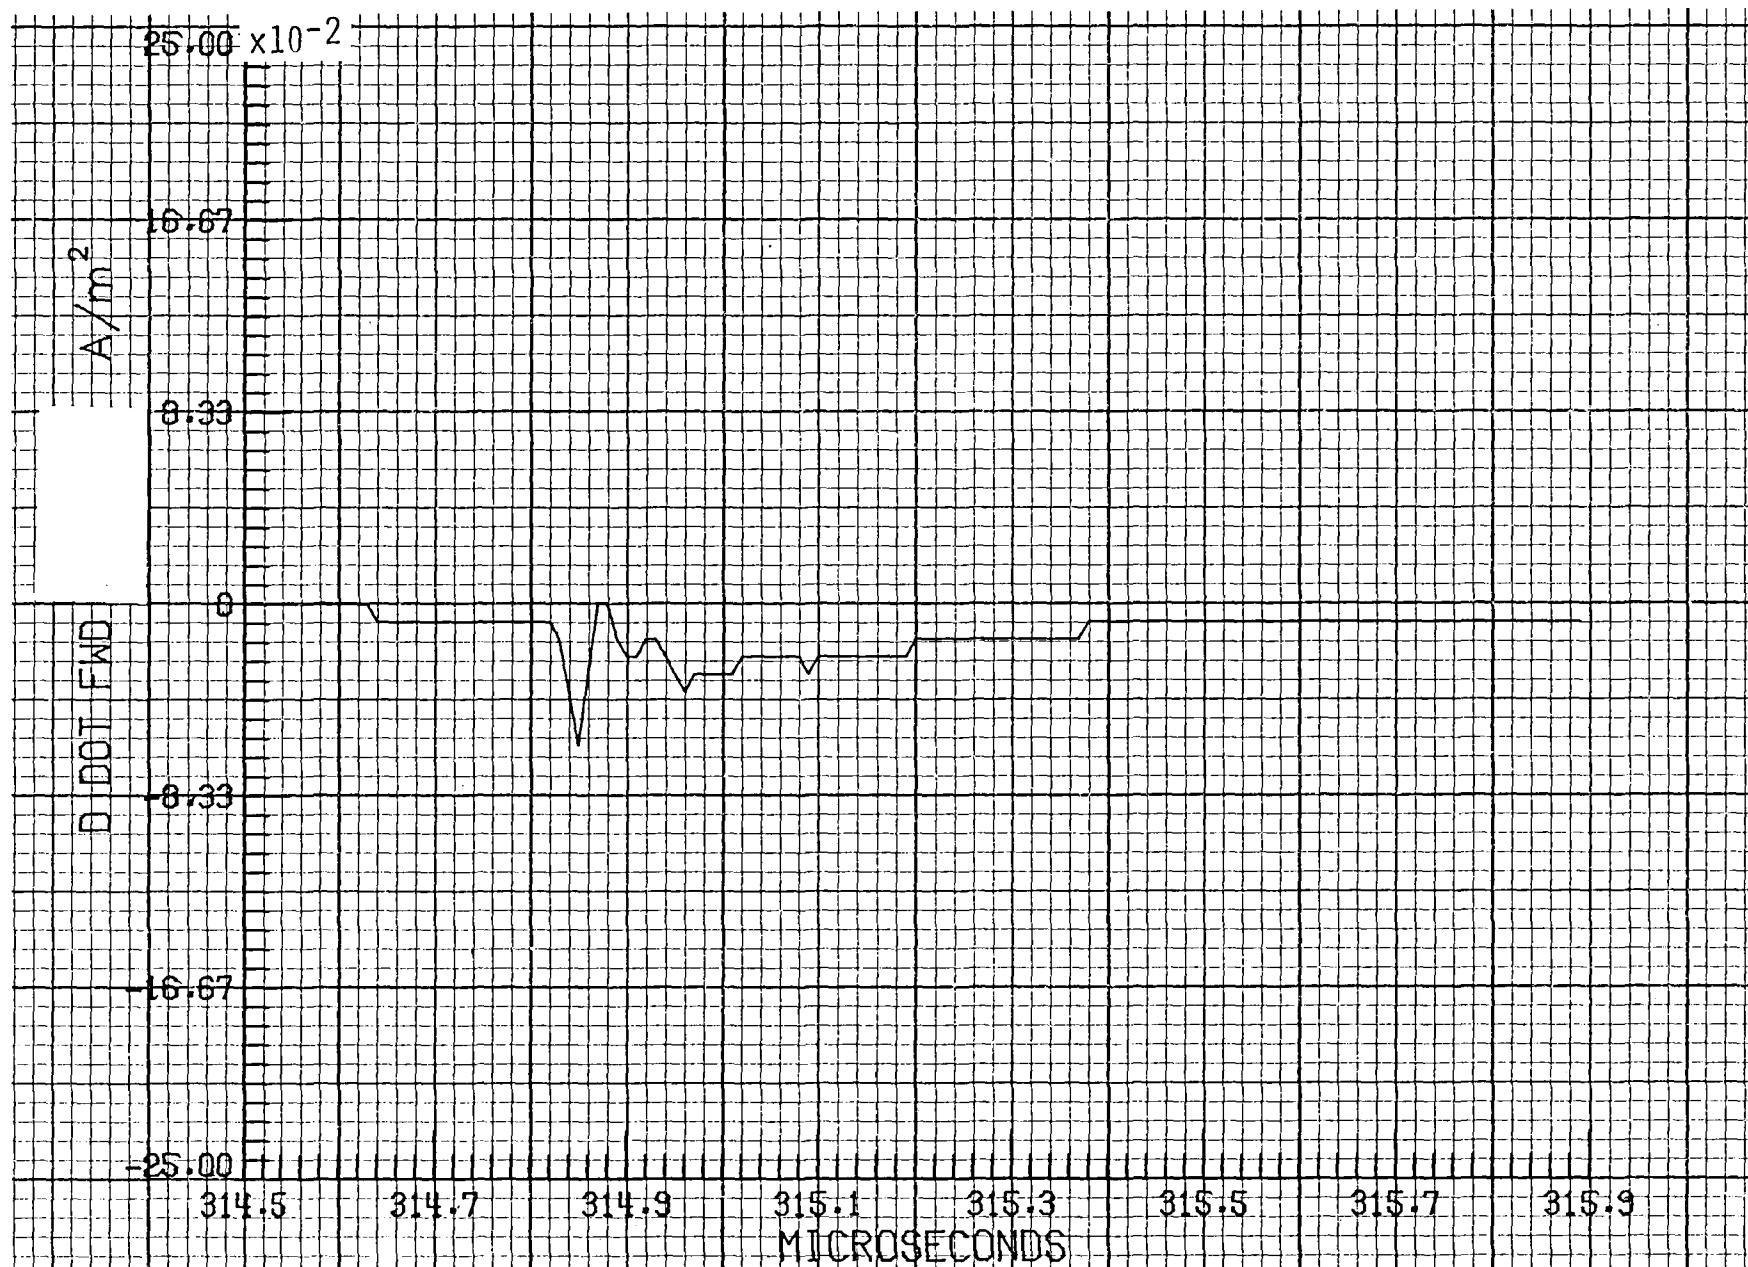
Figure 3. - D-dot sensor - flight 81-026, record 2.

(Continuation of Figure 2)

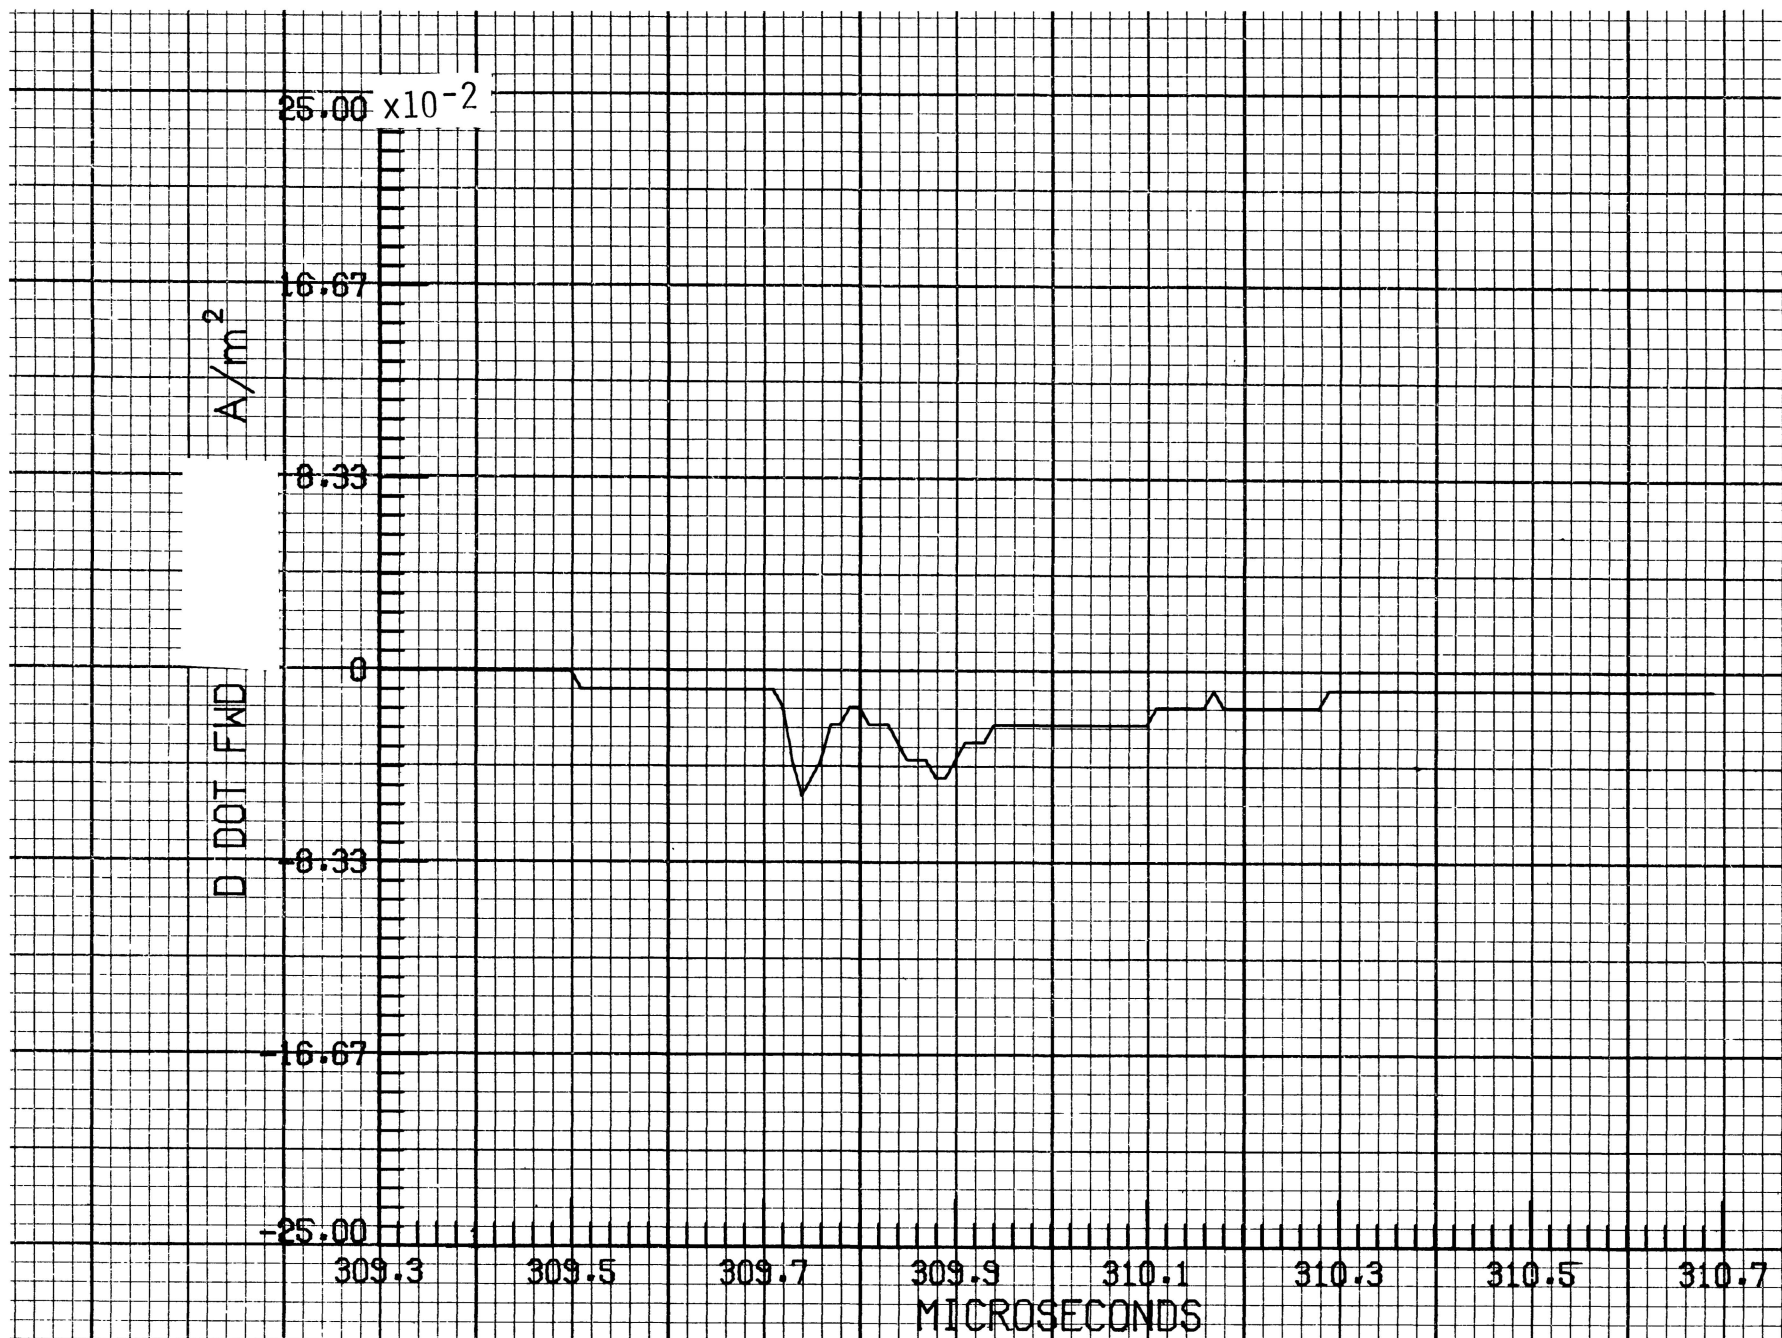
Figure 4. - D-dot sensor - flight 81-026, record 3.

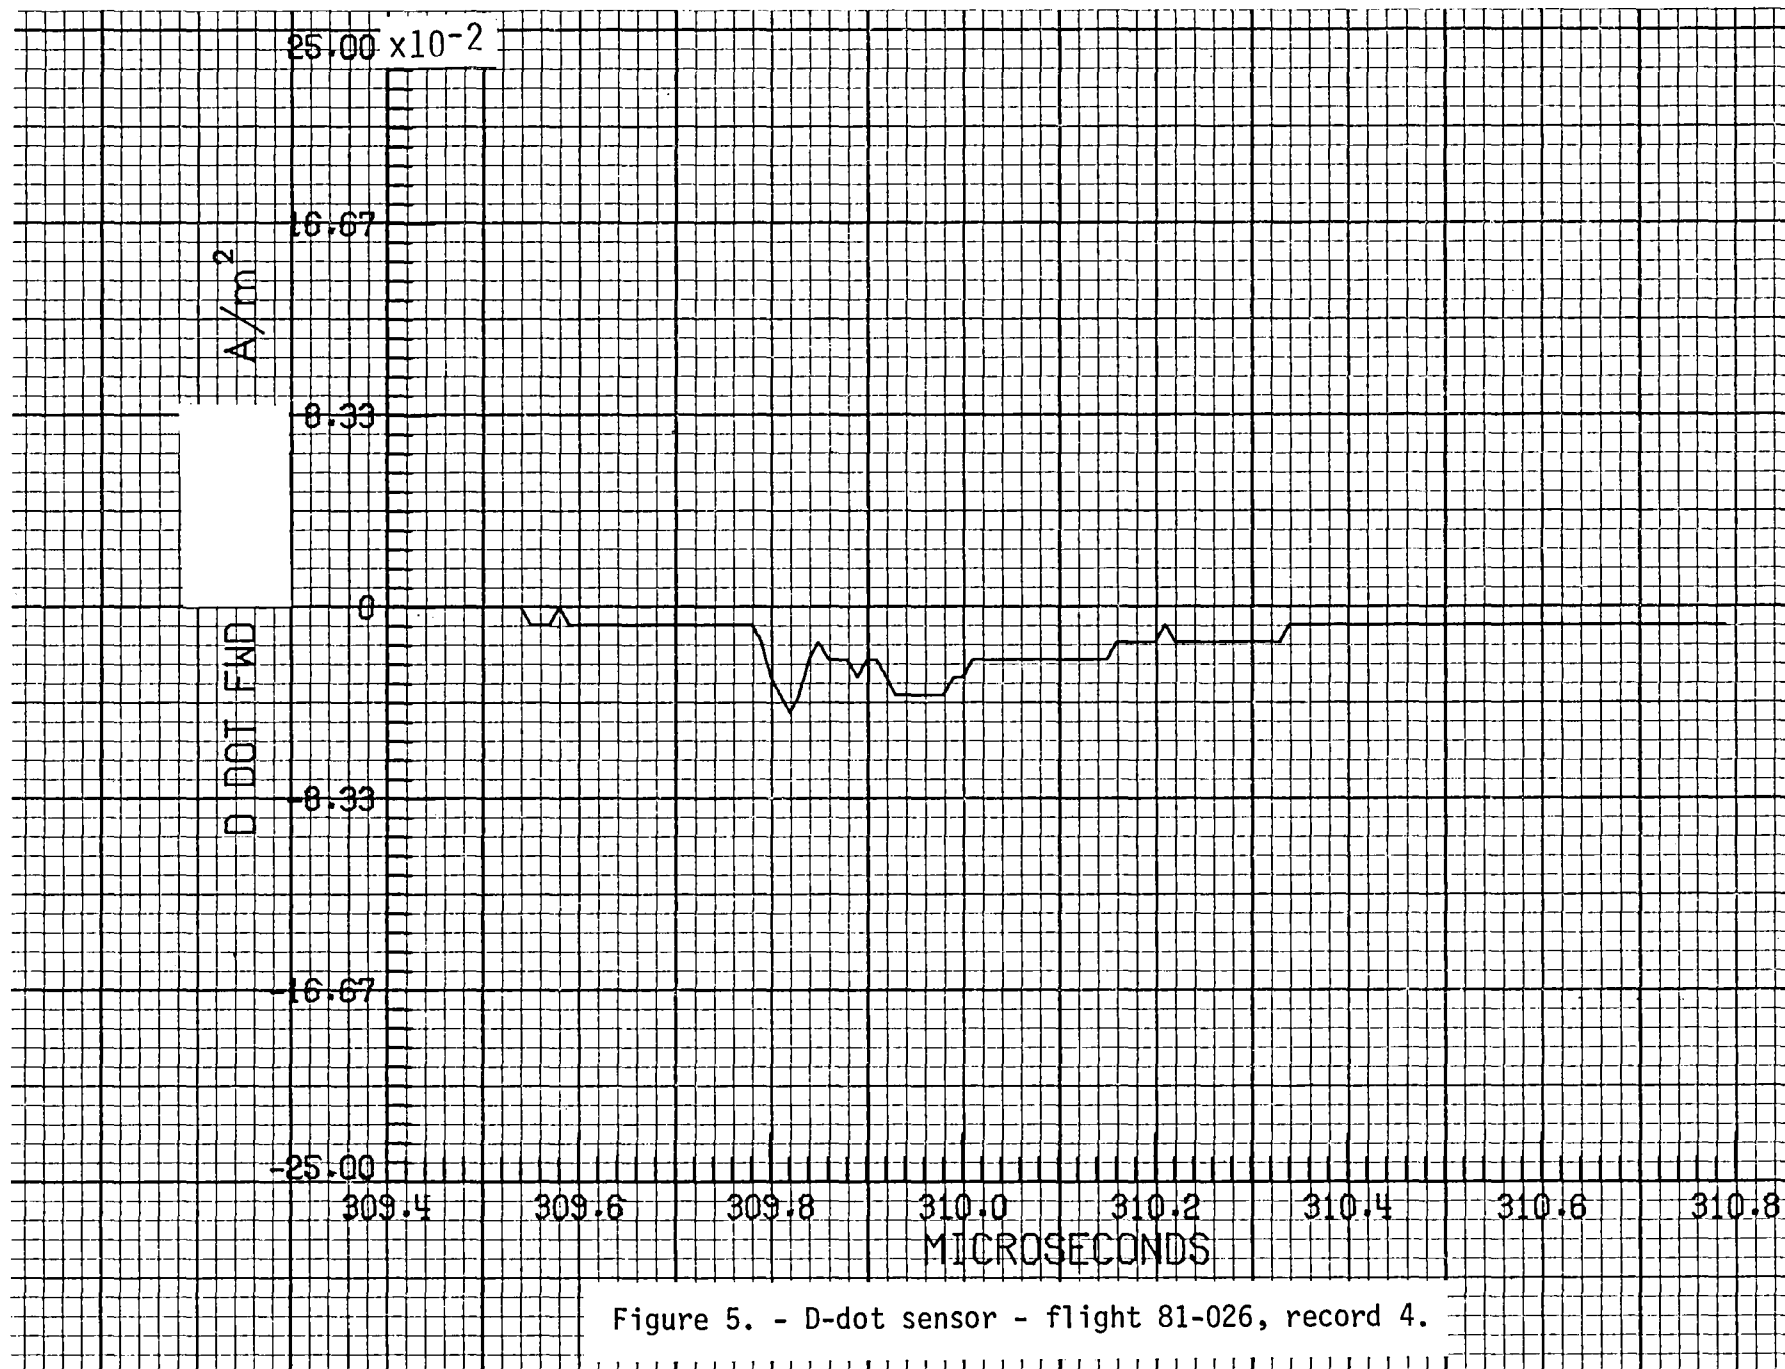
Figure 5. - D-dot sensor - flight 81-026, record 4.

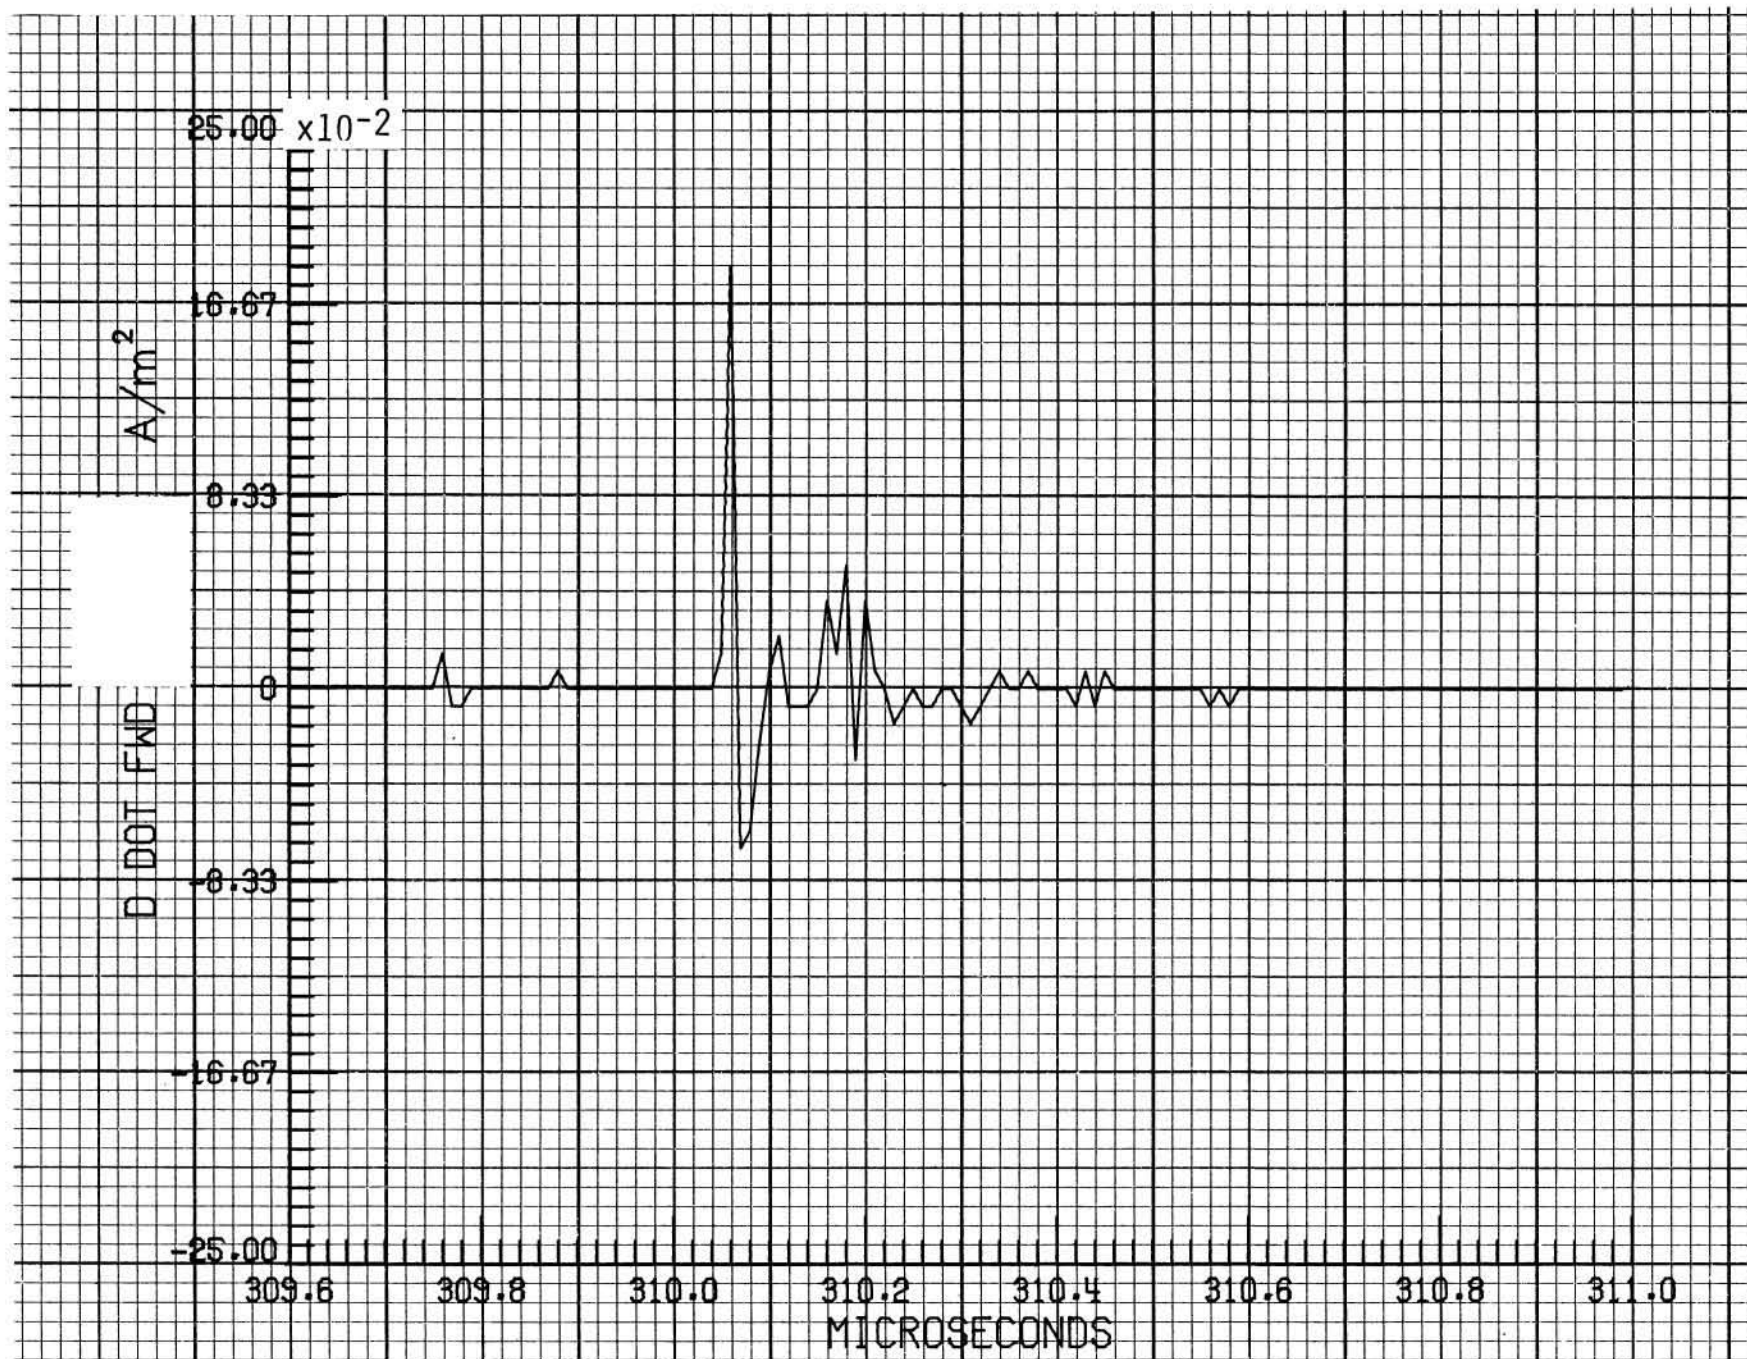
Figure 6. - D-dot sensor - flight 81-026, record 5.

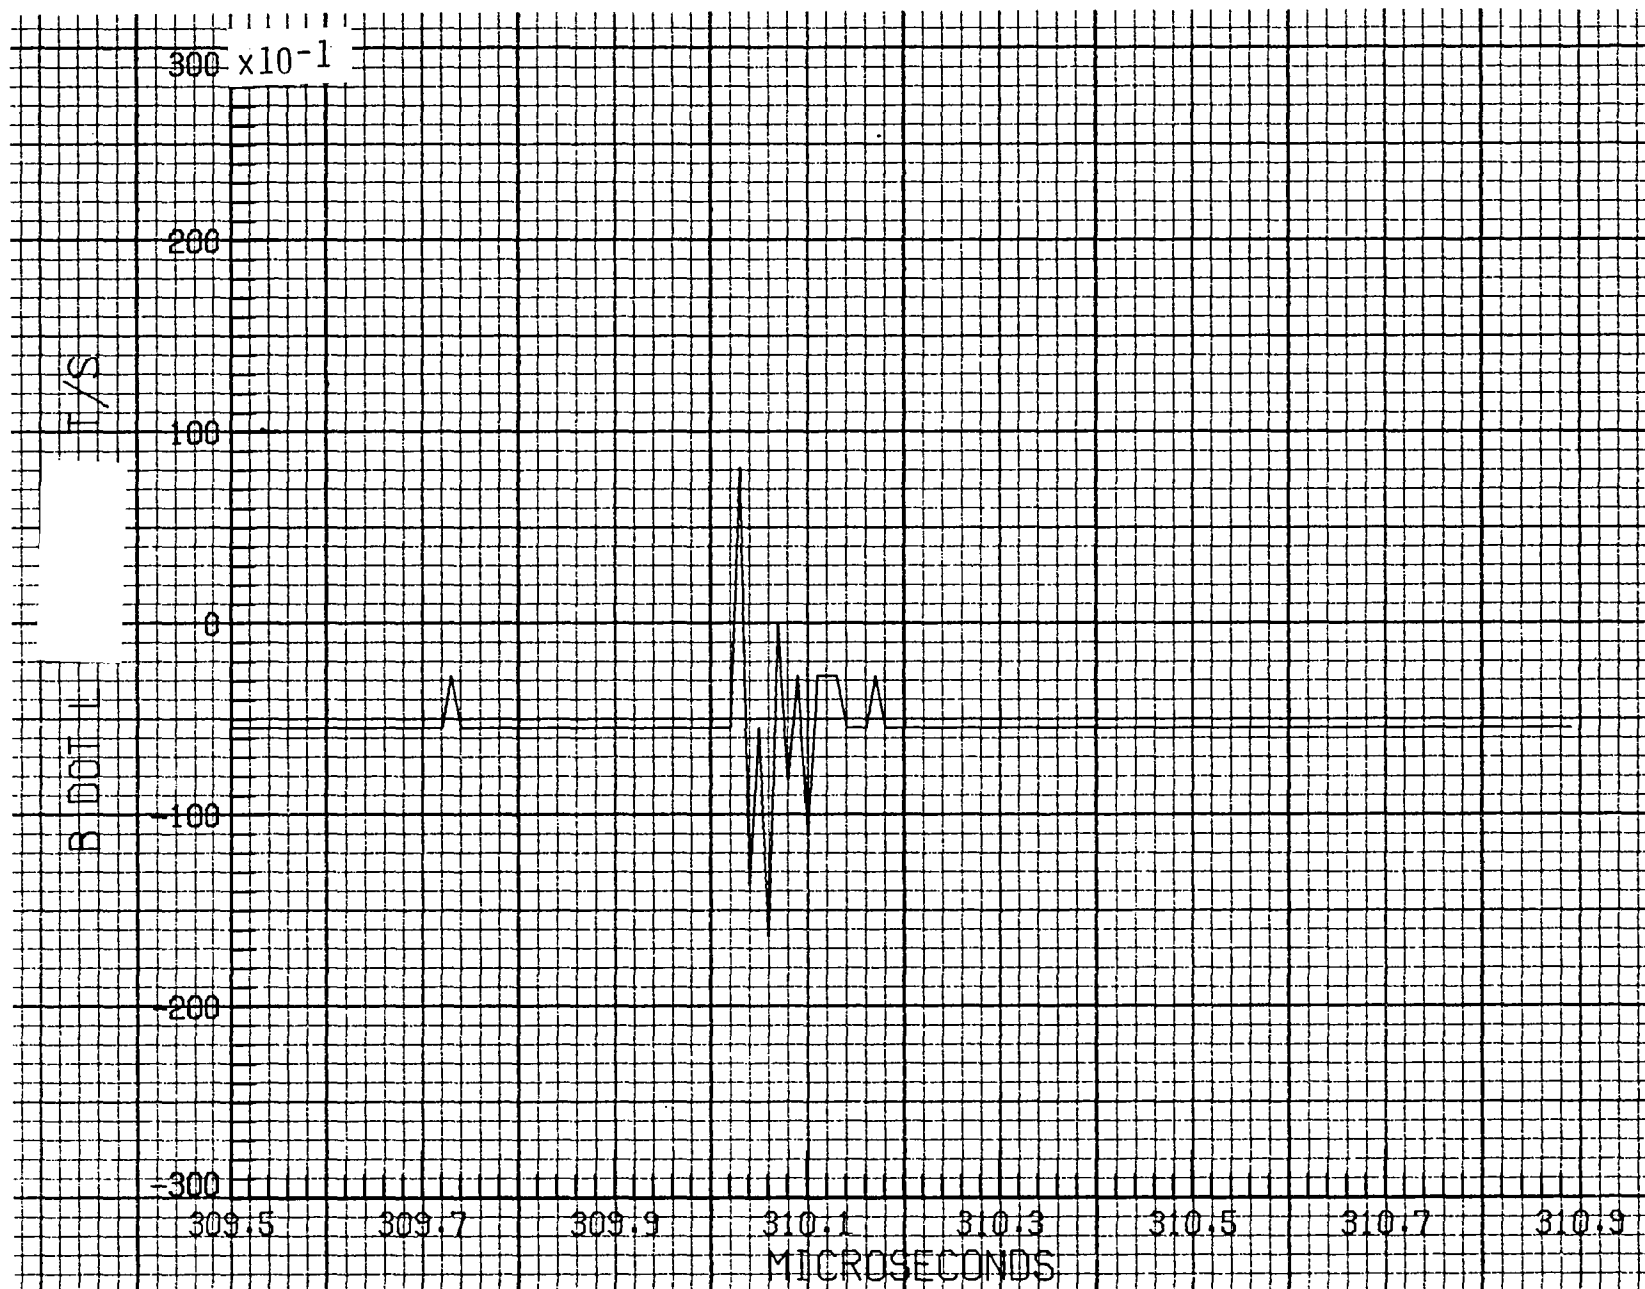
Figure 7. - B-dot sensor - flight 81-026, record 5.

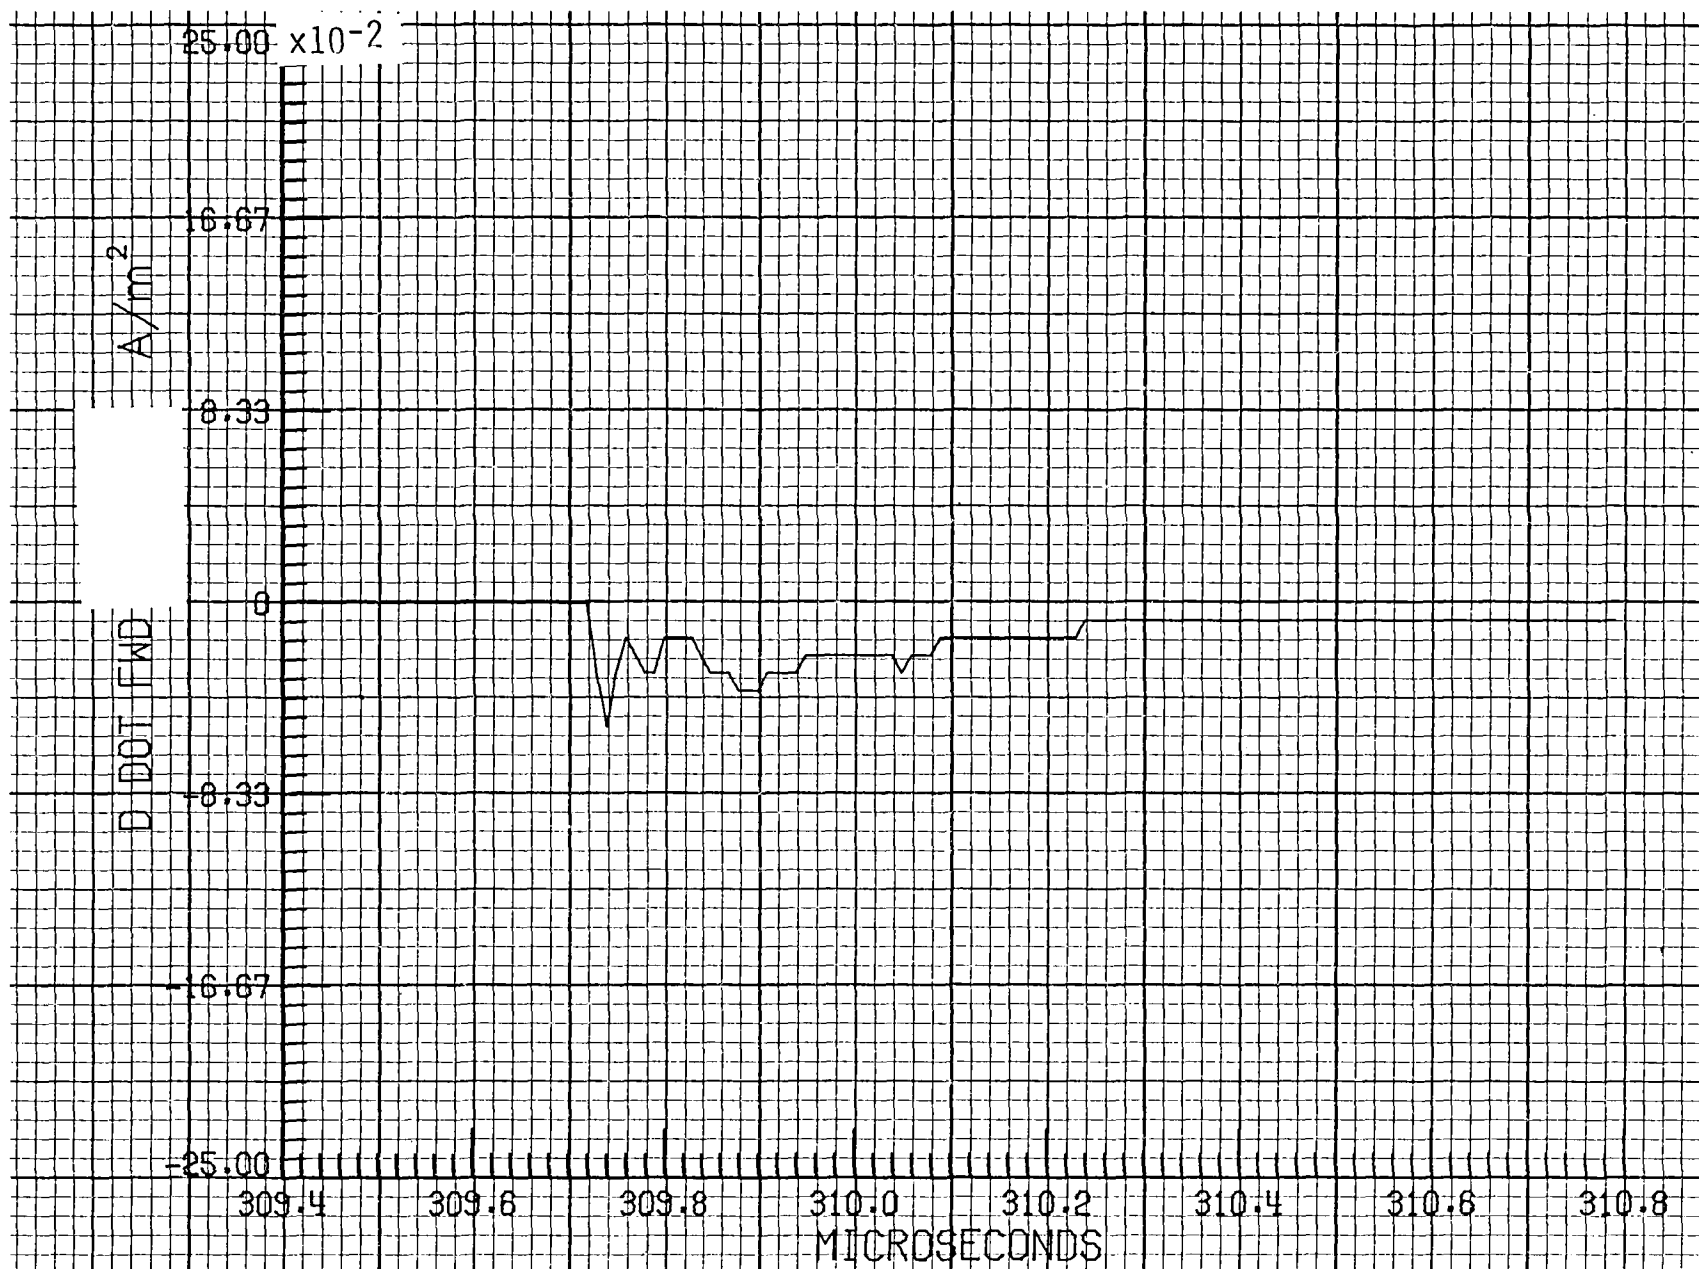
Figure 8. - D-dot sensor - flight 81-026, record 6.

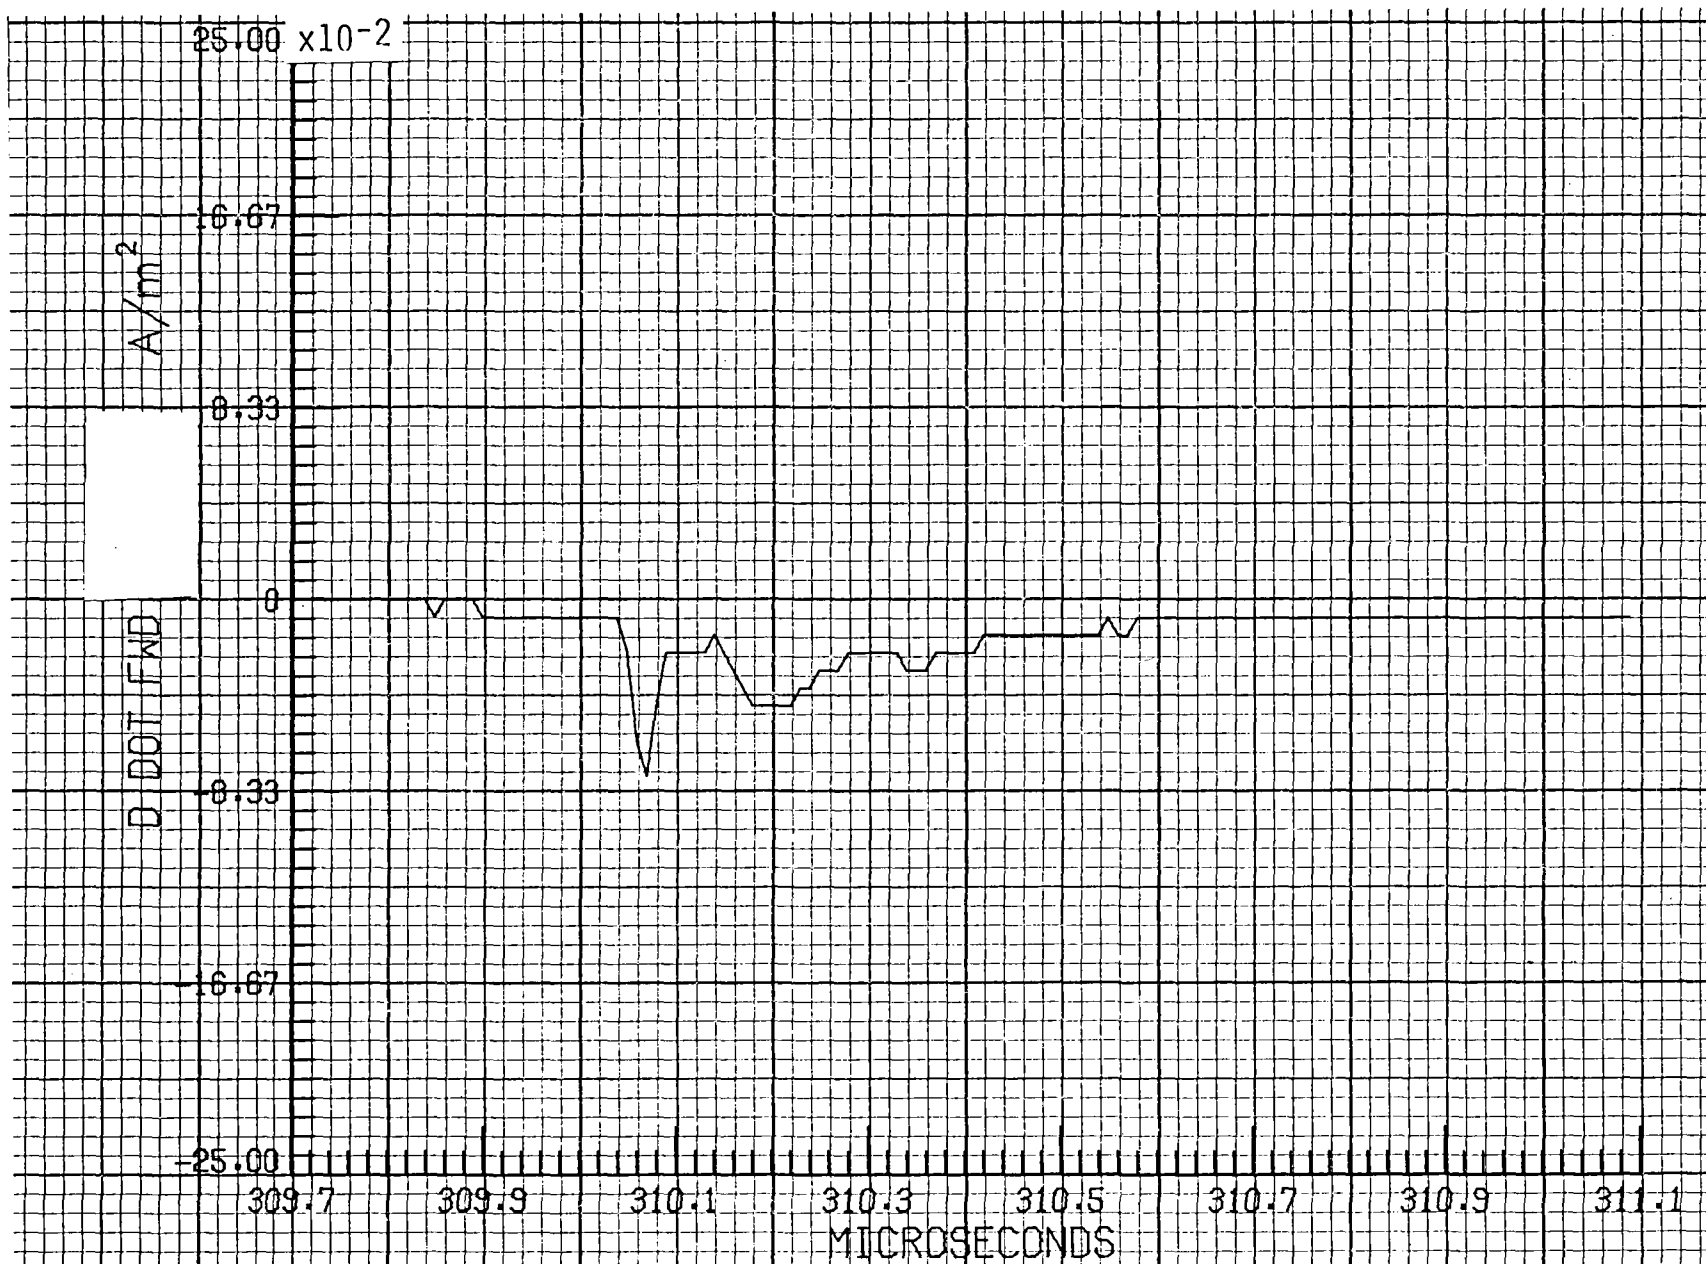
Figure 9 - D-dot sensor - flight 81-026, record 7.

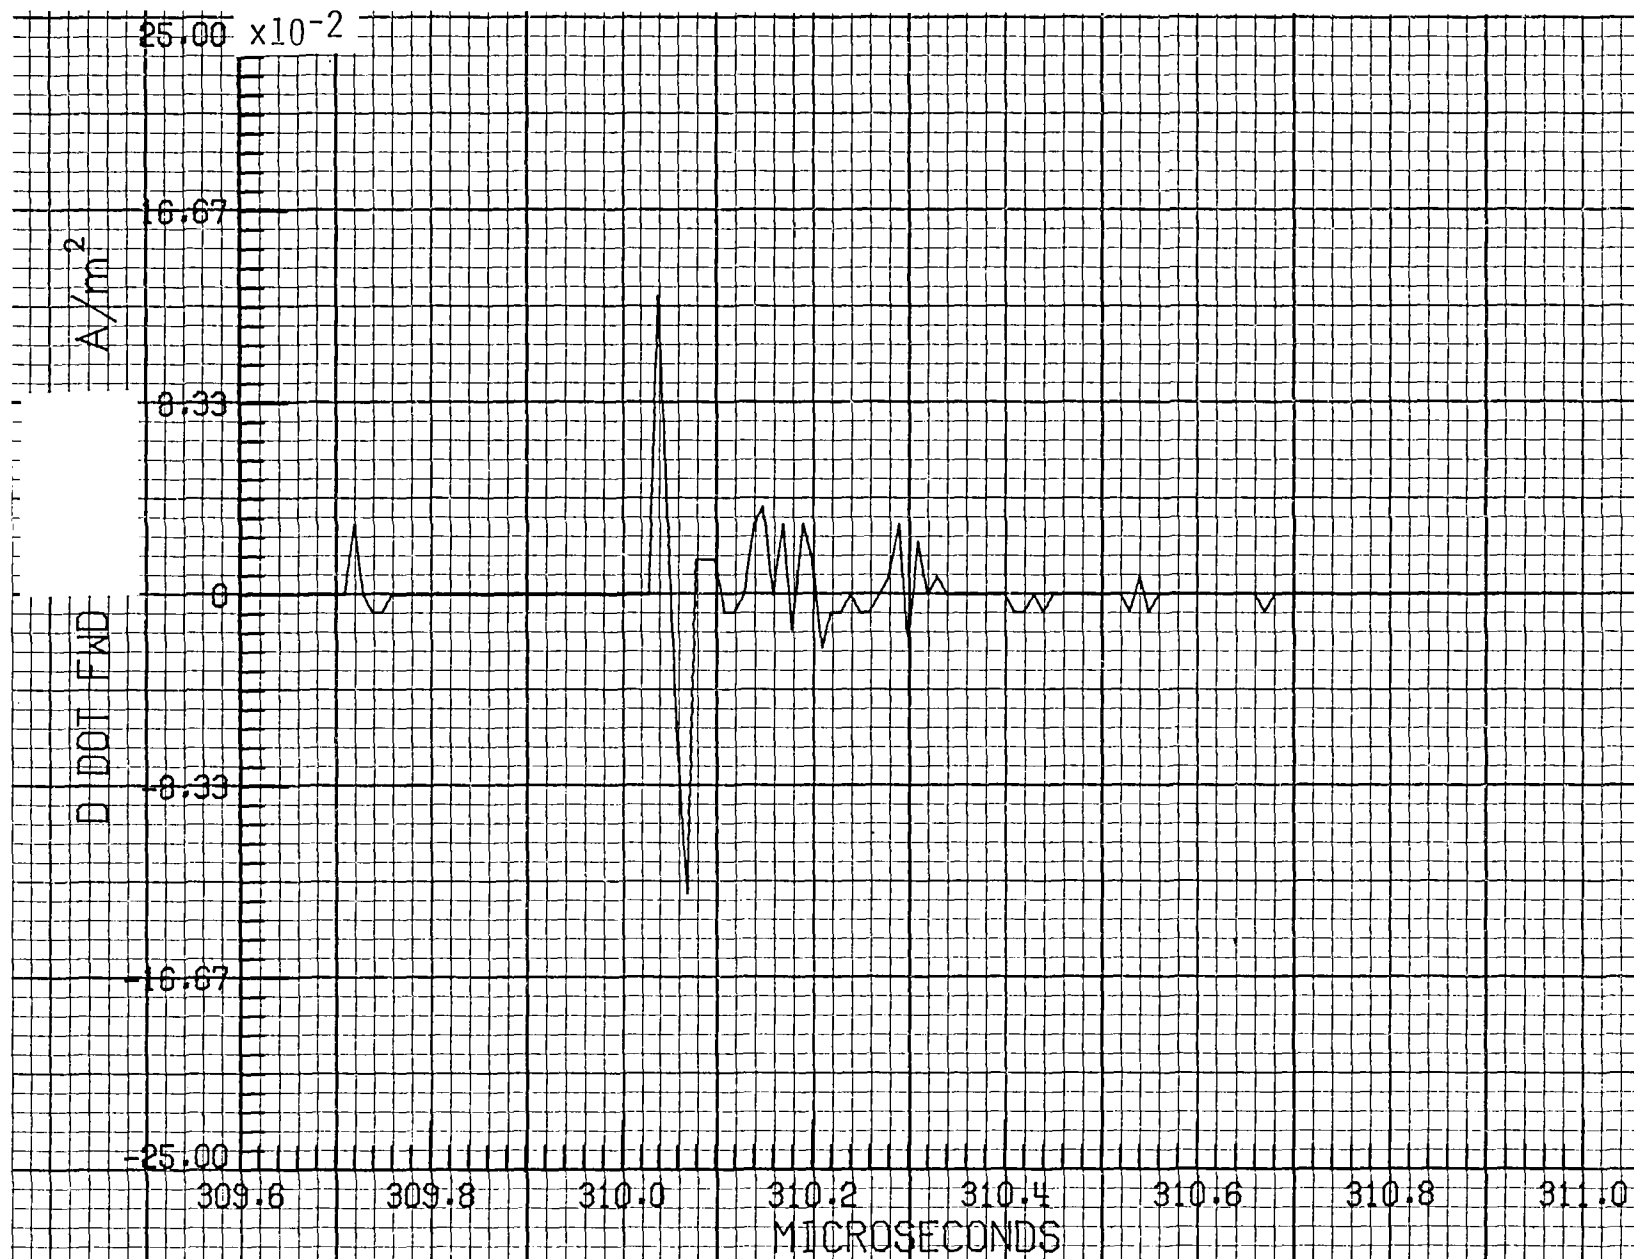
Figure 10. - D-dot sensor - flight 81-026, record 8.
